# LINCOLN AVENUE WATER COMPANY

ANNUAL  
REPORT  
OF  
OPERATIONS

# NORTH GLENROSE RESERVOIR

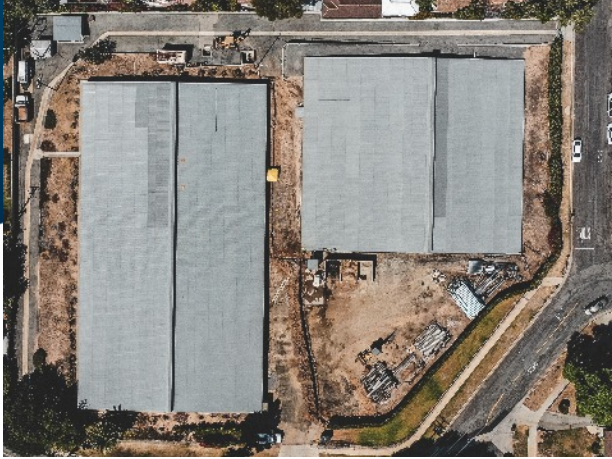
An arial view of the site before construction.

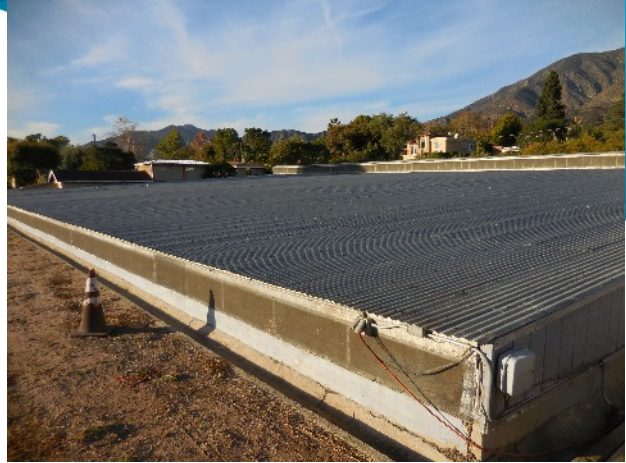
South east corner of the reservoir.

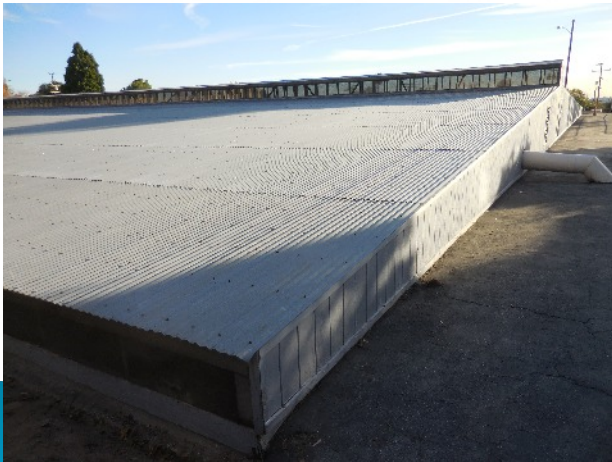
After sustaining significant damage from strong winds, the roof was rebuilt in 1999. Recent inspection showed the corrugated metal was still in good condition. However, the wood showed signs of deterioration.

While the concrete floor and corrugated metal roof was deemed to be in good condition, the inspection found that the wood frame and iron support columns had multiple areas of deterioration. It was decided that a reliable and robust concrete structure would be the best option for the important facility.

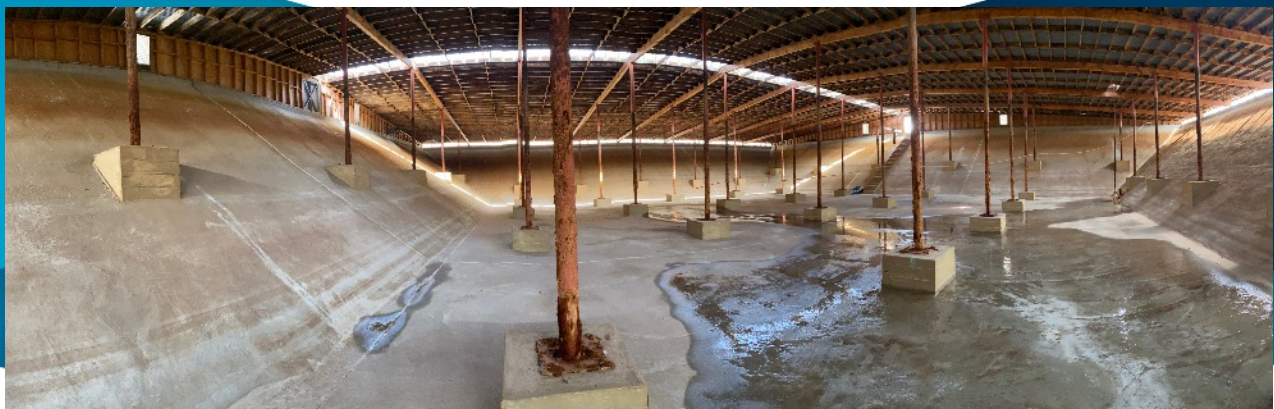
A panoramic view of the drained reservoir.

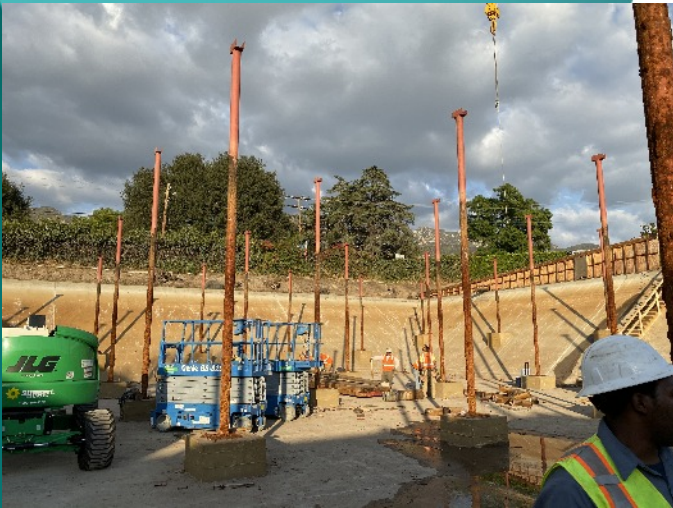
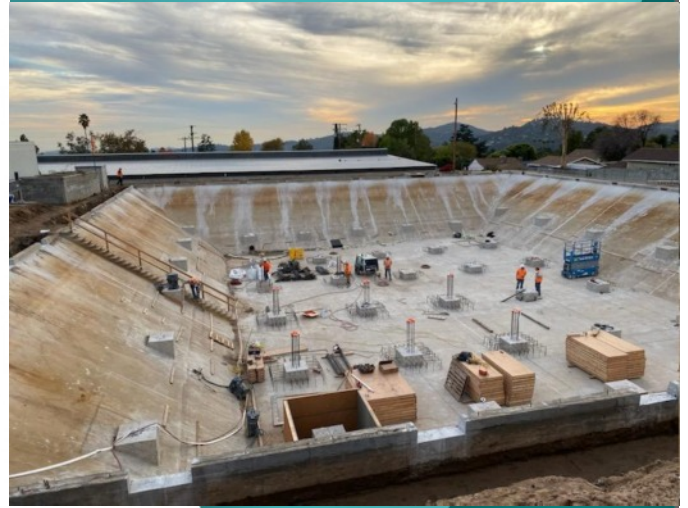
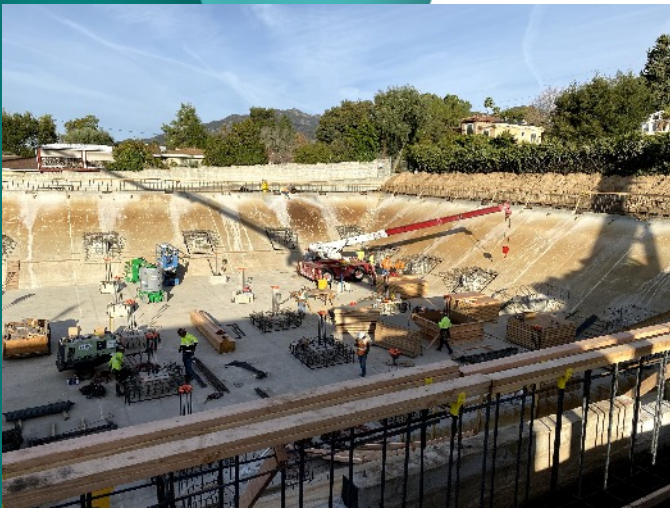
With the roof completely removed, once detached from the concrete footing, a crane was used to lift the old support columns out of the 18 foot deep reservoir.

Following a thorough cleaning, rebar is installed and forms are placed to increase the size of each footing. This was necessary to support additional weight of the concrete columns and roof.

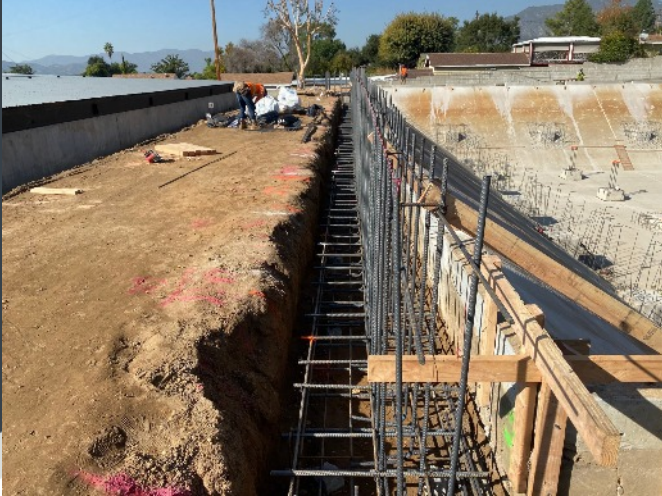
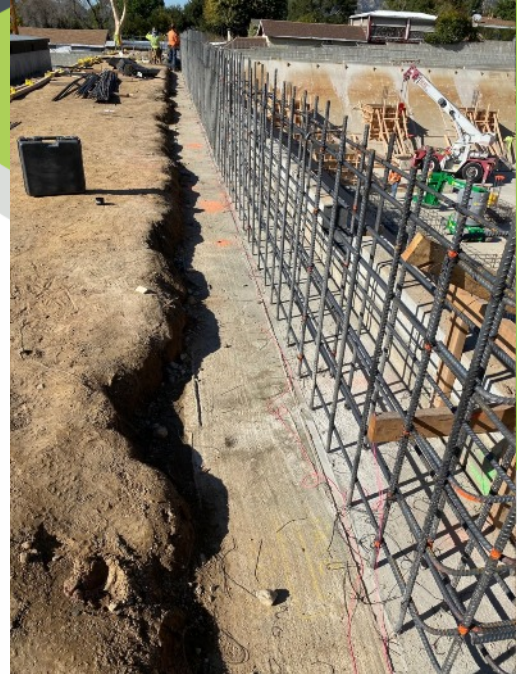
In addition to increasing the footing and column size it was also necessary to construct a new stem wall to further support the additional weight of the roof.

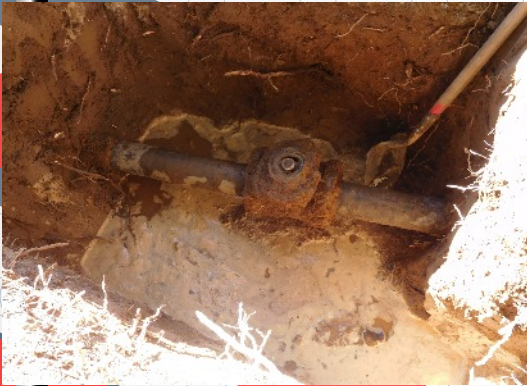
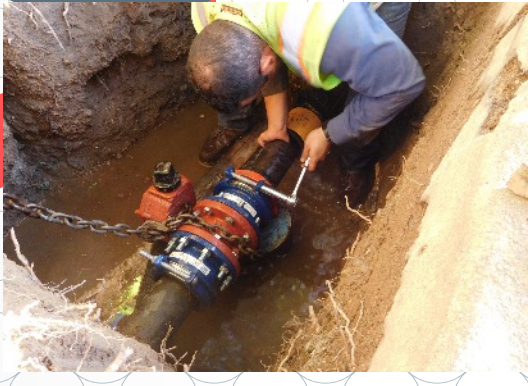
Pictured here is the Lincoln Avenue team repairing a leaking valve on Glenrose Avenue.

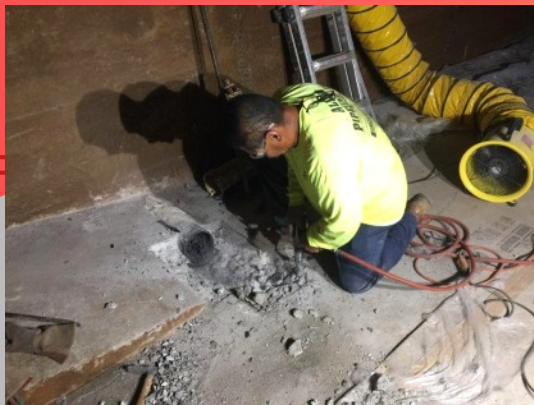
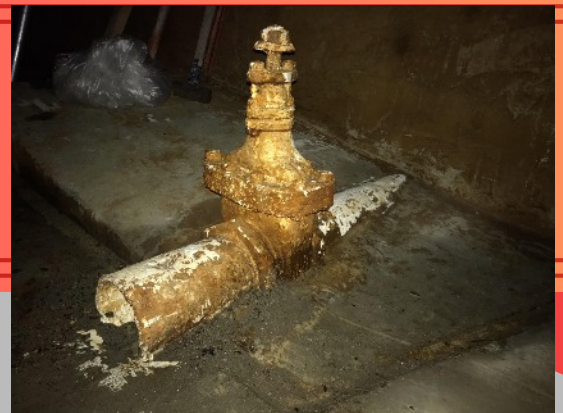
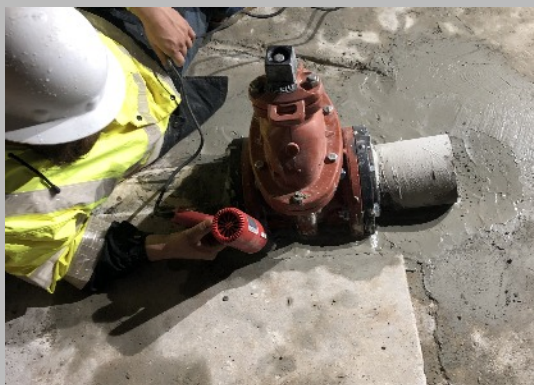
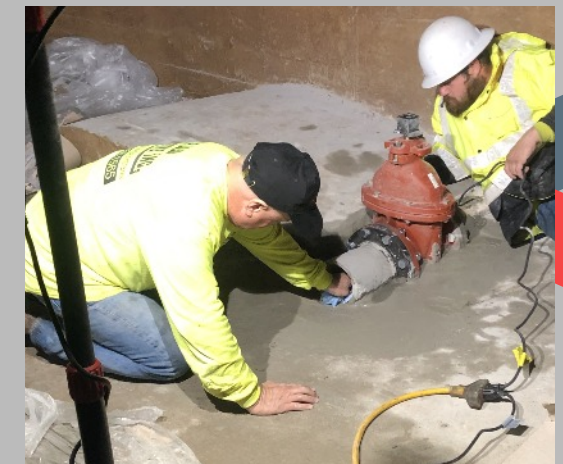
During scheduled maintenance we took the opportunity to replace this aged drain valve.

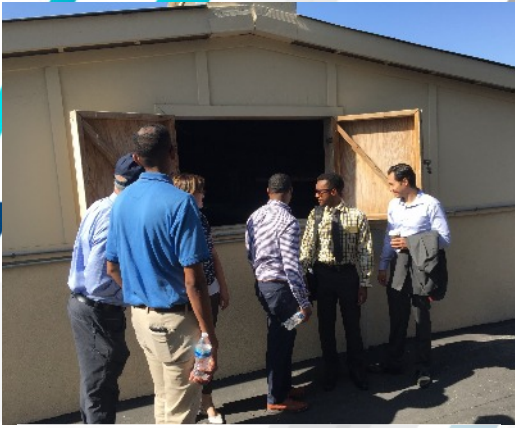
Taking a look into our 200,000 gallon treated groundwater storage facility.

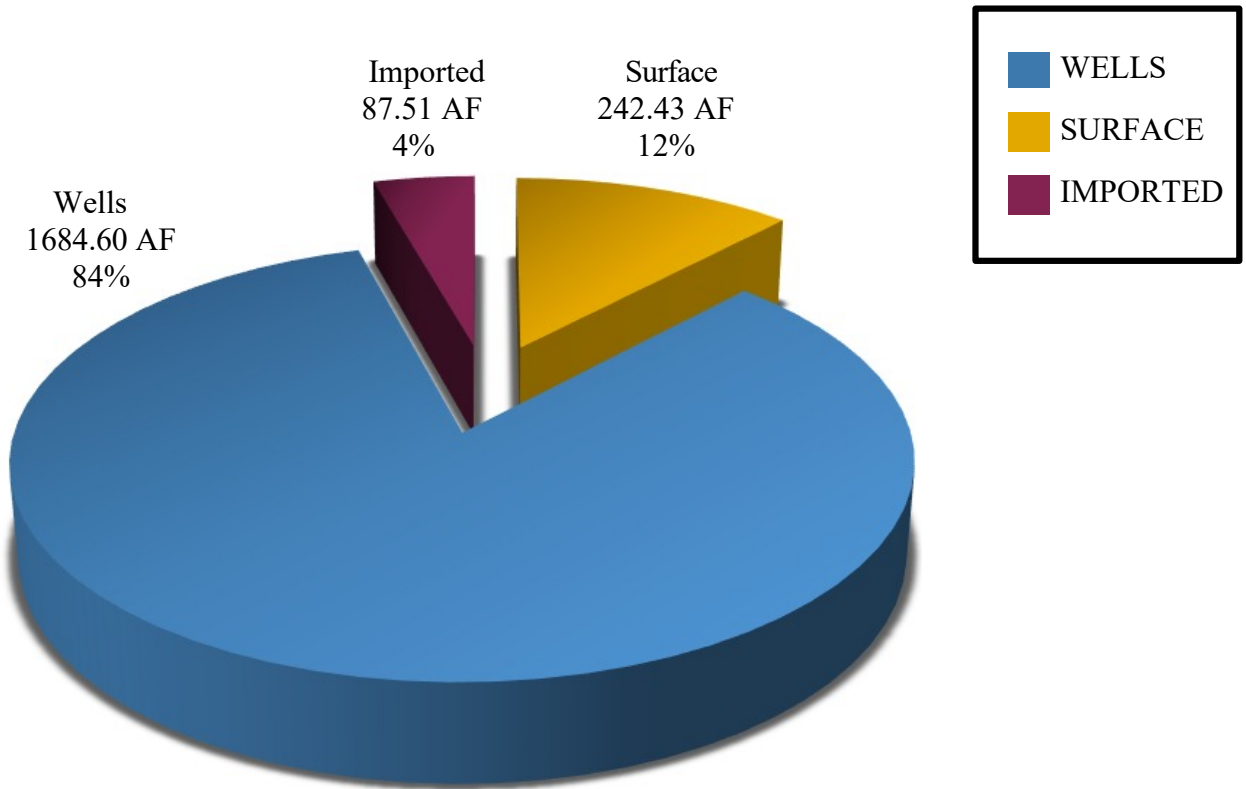
2019 WATER PRODUCTION  
BY SOURCE

Wells	1,684.60 AF
Surface	242.43 AF
Imported	87.51 AF
Total Production	<hr/> 2,014.54 AF
